WOOD DESTROYING PESTS AND ORGANISMS INSPECTION REPORT

Building No. 1799	Street Bali Court	City San Leandro	Zip 94578	Date of Inspection 06/06/17	Number of Pages 9
----------------------	----------------------	---------------------	--------------	--------------------------------	----------------------

Report # : 30004055
 Registration # : PR6613
 Escrow # :
 CORRECTED REPORT

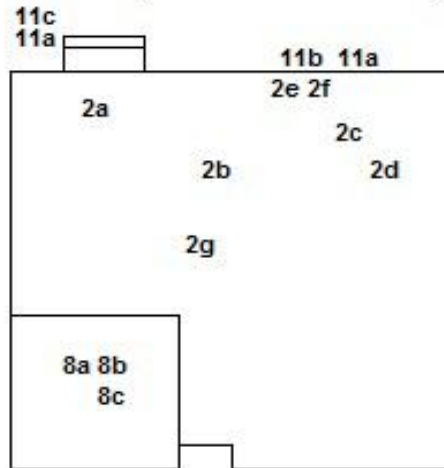
Diagram Not To Scale

2F - FINDING: Water damaged, noted as 2F on the diagram, was found to the baseboard under kitchen cabinet.

2G - FINDING: Water damaged, noted as 2G on the diagram, was found to the baseboard behind hall bathroom.

11C - FINDING: Stucco is cracked as indicated as 11C on the diagram. This condition is common in California and is considered to be conducive to infestation or infection (especially fungus infection). At this time we do not feel that this crack is infested.

RECOMMENDATION: Remove and replace the damaged wood members. This company does not paint.
****Section I Item****

RECOMMENDATION: Remove and replace the damaged wood members. This company does not paint.

RECOMMENDATION: Reseal crack with exterior caulking.
